We solved ragging problems for Western Avenue.

TWO 50HP
(37.5kW) PUMPS

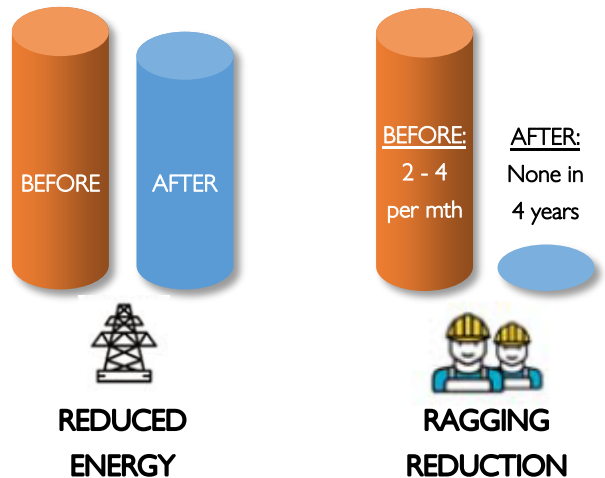
Ragging data from source, current and energy data taken over 2 week period.
